Assessing the Morphological Dynamics and Coastal Processes of the Kalu Ganga Estuary at Calido Beach, Kalutara, Sri Lanka: Implications for Sustainable Estuarine Management

*G.D.G.P.P. Gamage, A.D.N.T. Kumara

Faculty of Technology, South Eastern University of Sri Lanka

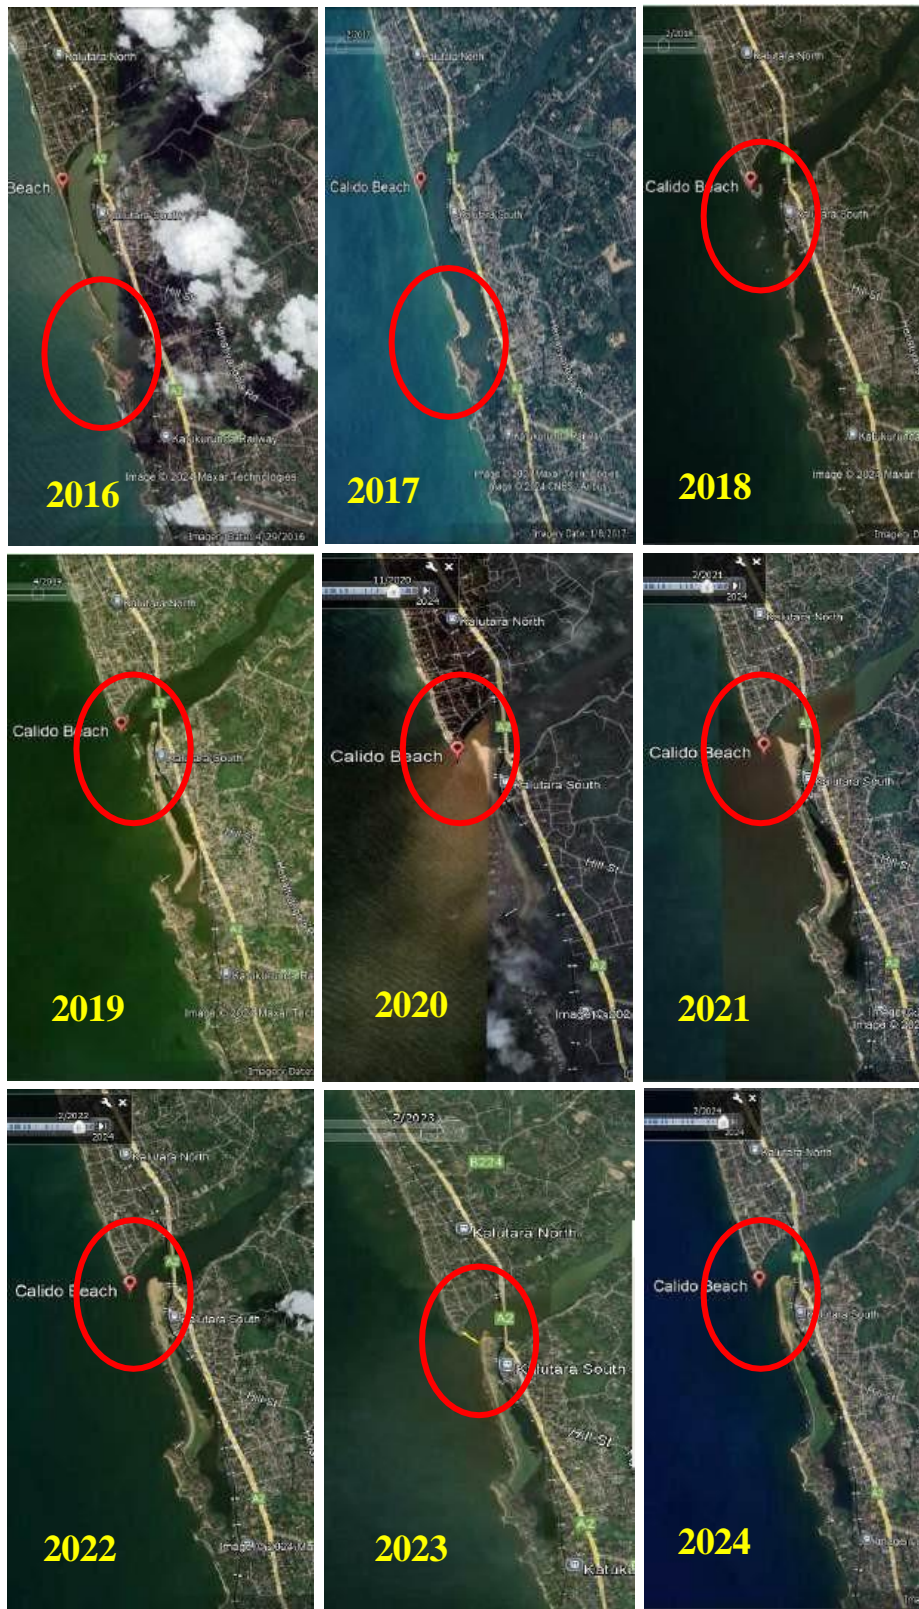
According to the table 01, the data reveals significant fluctuations in the width of the Kalu Ganga river mouth over recent years, with the narrowest measurement recorded at 72.83 m in 2017 and the widest at 317.79 m in 2019. These variations reflect a highly dynamic estuarine system in which periods of expansion and contraction alternate at the river mouth. Significant expansions were noted in 2018, 2019, and 2023, with thickness increasing significantly, likely due to increased flow velocities or sediment removal processes, either naturally or through anthropogenic activities. In contrast, contractions occurred in 2017, 2020, and 2021, potentially due to increased sediment deposition or reduced river flow (Fig. 03).

Fig. 3. Calido Beach in 2016 – 2024 Years Which Shows a Changes of Kalu River Mouth

Ratnapura which is about 100 km from the coast, and Kalutara, about 40 km away. This flooding event led to widespread landslides triggered by heavy monsoon rain [12]. During this period, the width of the river mouth decreased to 72.83 m, contributing to reduced water discharge velocity, which in turn may have exacerbated the effects of flooding by hindering efficient drainage.

In 2021, a severe storm, Cyclone Tauktae, brought heavy rainfall of up to 250 mm in 24 hours, with a peak of 336 mm recorded in Agalawatta in Kalutara District [13]. After this event, the mouth of the Kalu Ganga showed a widening to 97.90 m, which was probably due to the increased water discharge from the river during the storm event, which temporarily widened the mouth.

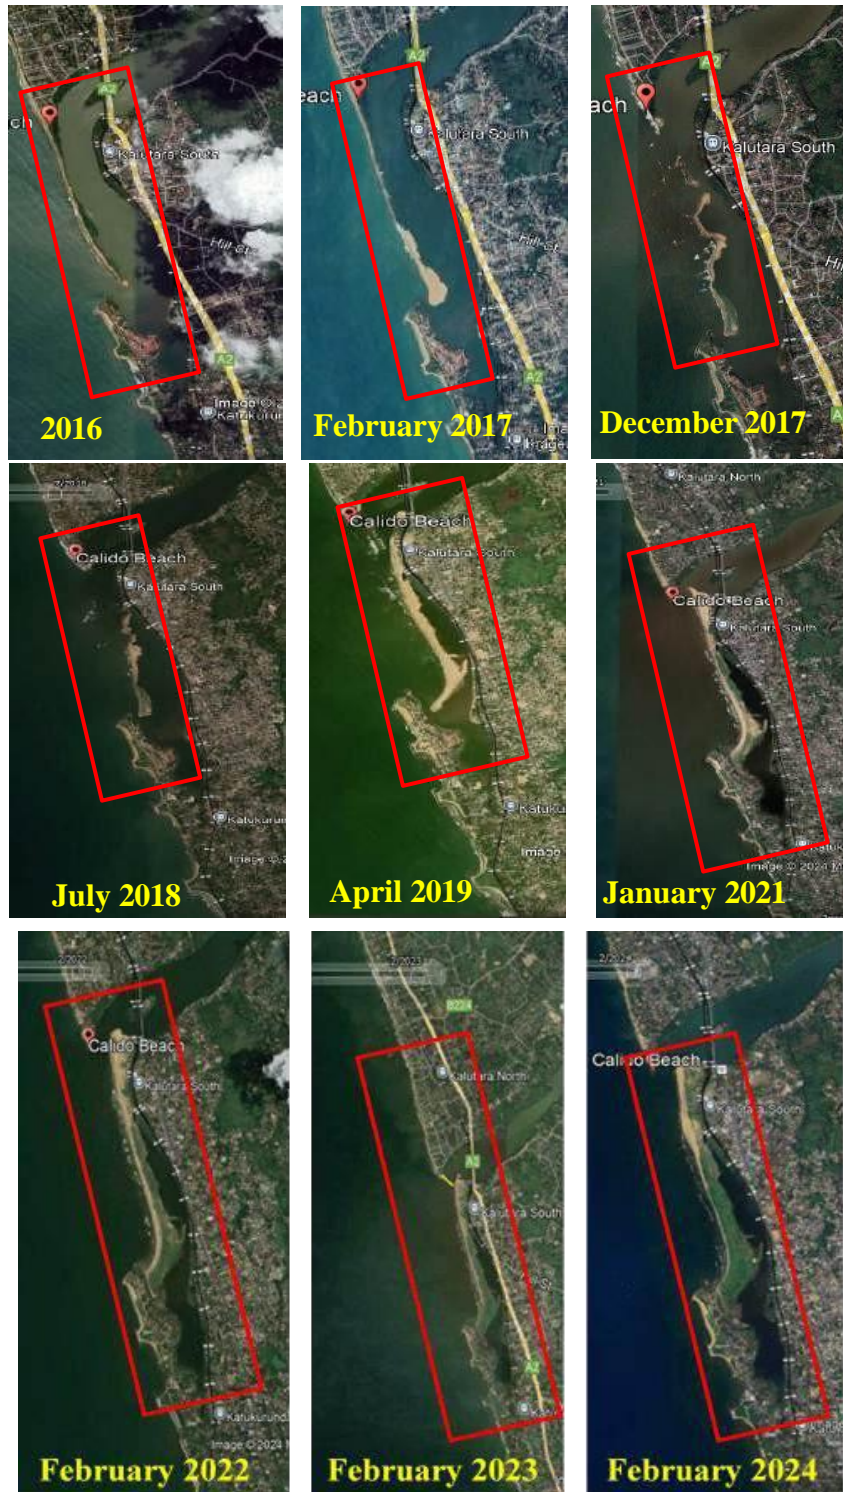
Since 2017, significant shoreline changes have been observed at Calido Beach in Kalutara, largely due to the removal of a sandbar. This area, the most eroded section of the Kalutara coast, previously showed minimal shoreline variation. However, comparisons of Calido Beach in 2017, 2018, and 2019 reveal not only ongoing erosion but also areas of new sediment deposition. This deposition is linked to increased sediment supply from the river as its flow intensifies. Deposited linked, in 2020 to 2024 time period settle around the Calido beach and Estuary area (Fig. 4).

Fig. 4. Sand Layer Losses and Changes at Calido Beach

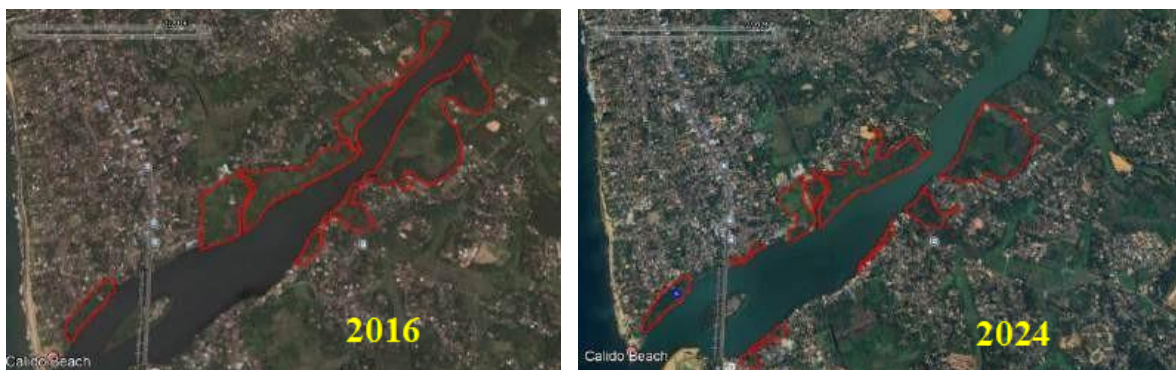
Comparing the Kalu Ganga river basin, Calido Beach, and Kalu Ganga Estuary between 2016 and 2024 shows a significant increase in synthetic environments developed with human infrastructure or altered landscapes, such as urban expansion, tourism hotels, road networks, and industrial sites (Fig 05). This intensification of synthetic environments has introduced significant ecological and geomorphological consequences. The increase in built-up areas around the Kalu Ganga basin has reduced the natural vegetation cover, leading to an increase in surface runoff and the erosion of riverbanks and coastal zones. The lack of natural vegetation and the corresponding loss of root systems along the river and coast have destabilized the soils and made the region more vulnerable to erosion from both river currents and wave action.

Fig. 5. Land Use and Land Cover Changes in 2016 and 2024 Years
